## 1.0 INTRODUCTION AND BACKGROUND

Each year, personnel from the U.S. Army Corps of Engineers (Corps), Sacramento District, and their local sponsor, the California Department of Water Resources (DWR), conduct a field reconnaissance review of the Sacramento River Flood Control System. Since 1997, Ayres Associates has assisted the Corps and their local sponsors with this annual review and inventory of erosion sites. **Figure 1** shows the overall extent of waterways observed in this field review.

### **3.0 FIELD RECONNAISSANCE COVERAGE AND PROCEDURES**

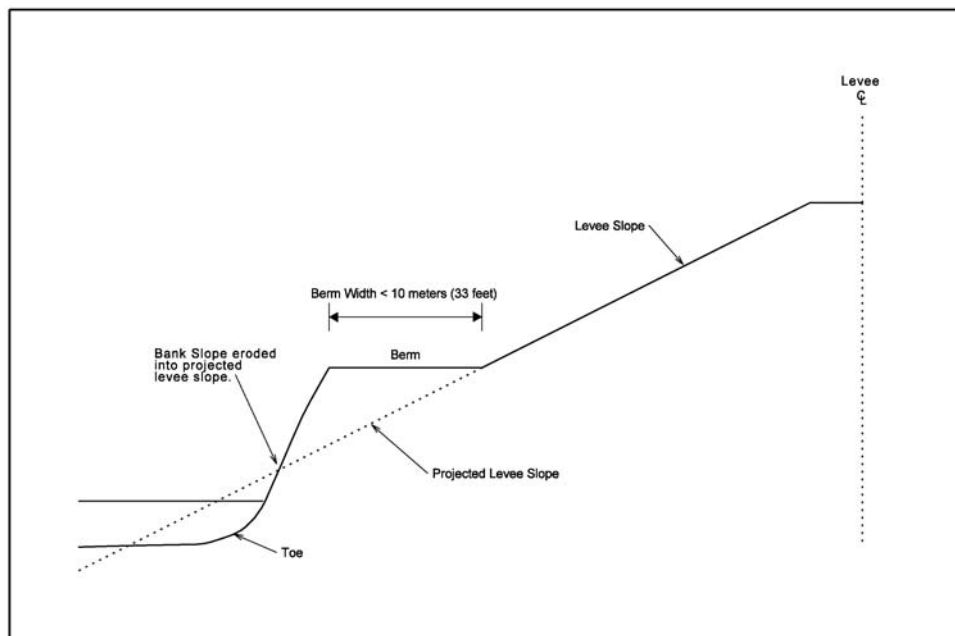
**Figure 2. Schematic of Inventory Erosion site Criteria**

**Figure 2** shows a schematic illustrating these two criteria.

- a) Approximate River Mile as per 1991 Corps River Atlas
- b) Right or left bank
- c) GPS Waypoint designation
- d) Estimate site length (visual estimate)
- e) Erosion location on the bank (toe, mid bank, upper slope, etc.)
- f) Erosion mechanism
- g) Existing revetment type, if any
- h) Proximity of erosion to the levee slope
- i) Remaining berm width
- j) Field notes or comments for current inspection year.
